MASSACHUSETTS COASTAL BASIN
PEABODY, MASSACHUSETTS

FOUNTAIN POND DAM
MA 00191

PHASE I INSPECTION REPORT
NATIONAL DAM INSPECTION PROGRAM

OCTOBER 1979

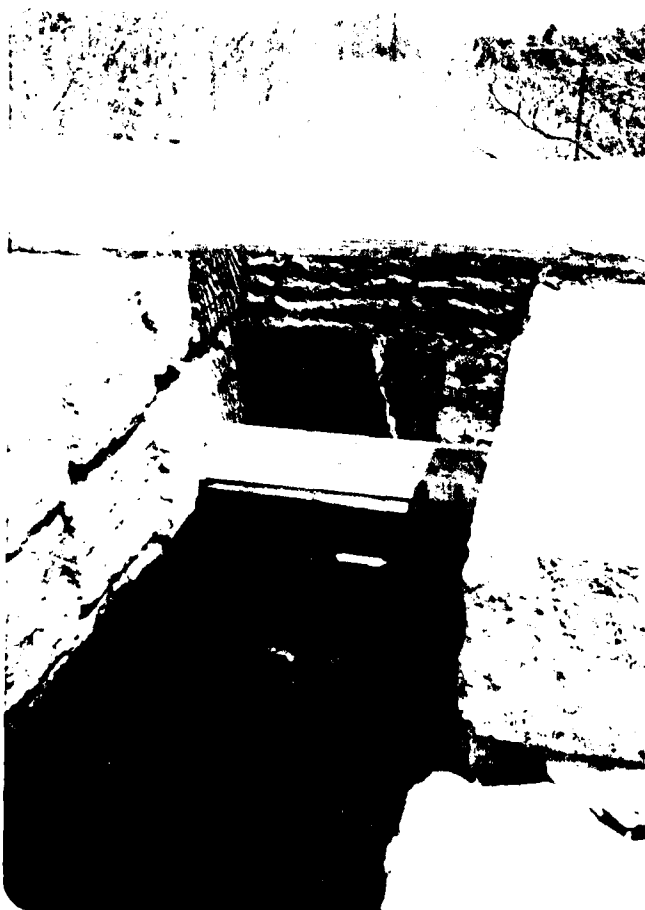
NO. 2 UPSTREAM VIEW OF SPILLWAY AND STOPLOGS

Leaves and soil have settled out upstream of the stoplogs on the spillway. Much of the mortar has been lost between the granite blocks. Debris and several small boulders were observed in the discharge channel. Trees are growing along the east side of the channel.

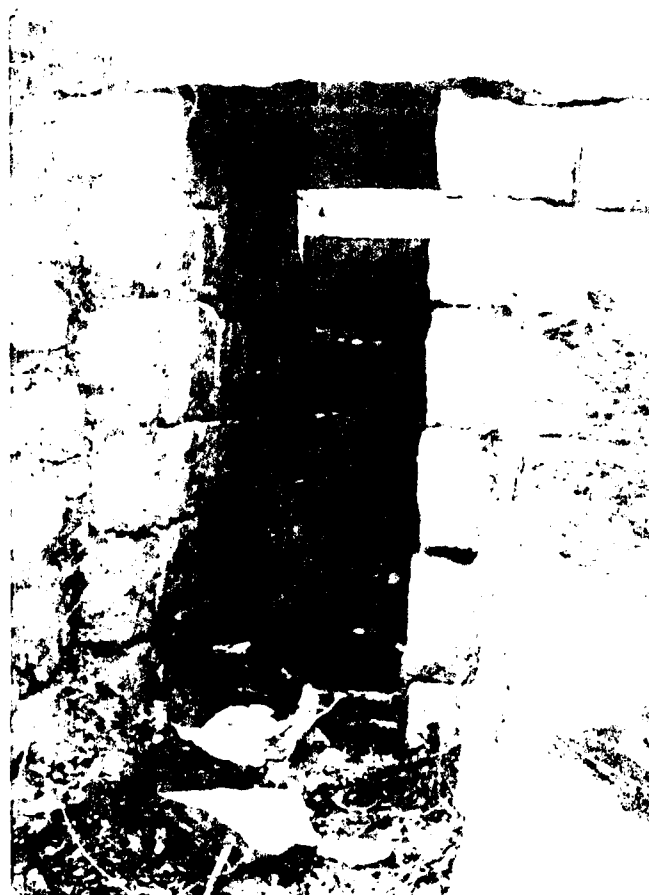
The mortar and chinking between the stone blocks has for the most part, been lost (see Photograph C-6) leaving large continuous voids between the blocks. Leaves, trash and other debris have accumulated against the stoplogs in the spillway. Water was leaking at about 3 to 4 gallons per minute around the stoplogs through one open joint on the left abutment.

NO. 6 DOWNSTREAM VIEW OF SPILLWAY

inspections during and after severe storms. Maintenance should include clearing of debris from the spillway and discharge channel, clearing of trees, brush and debris from the slopes, and repair of erosion to slopes, or to the mortar in the spillway. All repairs should be undertaken in accordance with all applicable State regulations;
